Leicester Public Schools – FACILITIES MASTER PLAN

5.0 Existing Conditions Analysis / Documentation

Central Office Building

LEICESTER PUBLIC SCHOOLS CENTRAL OFFICE BUILDING

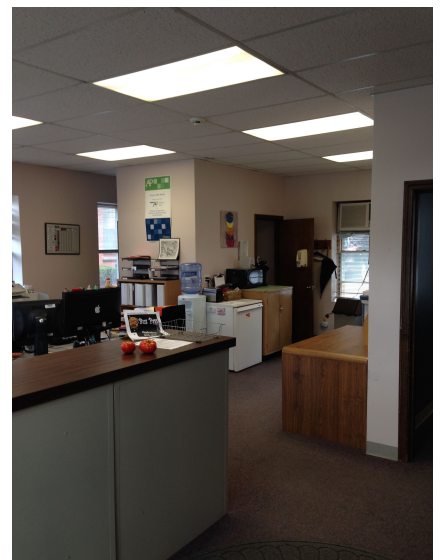
Interior – Copy Area, First Floor

- Water damage is evident on the carpet next to windows in Copy Room. This area needs to be examined for source of water leak and repaired.
- There are several types of doors used in the building. A few doors show deterioration and require refurbishment/replacement.

- Some wood doors are at the end of their expected life and should be replaced.
- Floor finishes show excessive wear and will need to be replaced.
- Water damage is evident on the carpet in Copy Room. New carpet or alternative floor finish is needed in this area.
- Ceilings range from fair to good condition, with little apparent water damage. Some repair may be needed.

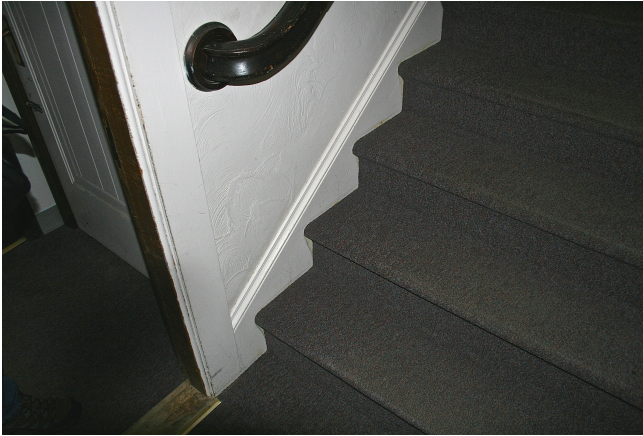
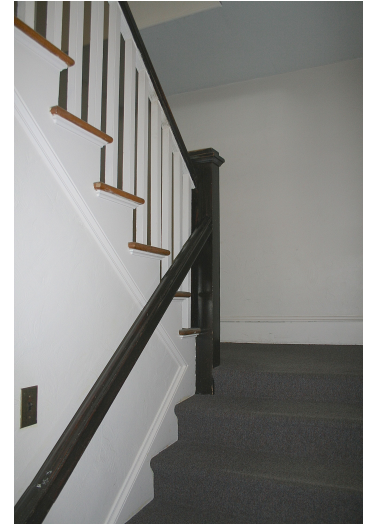
Existing Main Stair

- There is no accessible parking or accessible path from parking to front entry.
- There is no elevator between floors.
- The interior stair and handrails are not compliant with current Code.

8	GUARDRAILS, HANDRAILS, TREADS AND RISERS DO NOT COMPLY WITH ACCESSIBILITY AND CURRENT BUILDING CODE REQUIREMENTS	REPLACE GUARDRAILS AND HANDRAILS	3
9	RECEPTION DESK DOES NOT COMPLY WITH ACCESSIBILITY REQUIREMENTS.	PROVIDE CODE-COMPLIANT MODIFICATION TO DESK	1
10	SECOND FLOOR IS NOT HANDICAPPED-ACCESSIBLE	INSTALL ELEVATOR	3
11	ACCESSIBLE DRINKING FOUNTAIN NOT PROVIDED	INSTALL CODE-COMPLIANT HI-LO DRINKING FOUNTAIN	3
12	LEAK AT NORTH SIDE OF BASEMENT	INVESTIGATE, REPAIR WALLS	1
13	PLASTER AND PAINT FINISHES AT END OF EXPECTED LIFE	PATCH AS NEEDED, APPLY NEW FINISHES	3
14	PAPER GOODS ARE BEING STORED IN WET CONDITIONS	RELOCATE/PROPERLY STORE RECORDS AND MATERIALS	1
15	FLOORING IN POOR CONDITION, EXCEEDED LIFE EXPECTANCY	INSTALL NEW FLOORING THROUGHOUT	3
16	ROOM SIGNAGE IS NOT CODE-COMPLIANT	INSTALL CODE-COMPLIANT ROOM SIGNAGE	1
17	THERE IS NO ACCESSIBLE PATH TO PARKING, NO HANDICAPPED PARKING PROVIDED	ADD ADA-COMPLIANT PARKING, RECONFIGURE SIDE DOOR TO ALLOW FOR HANDICAPPED ACCESS	1

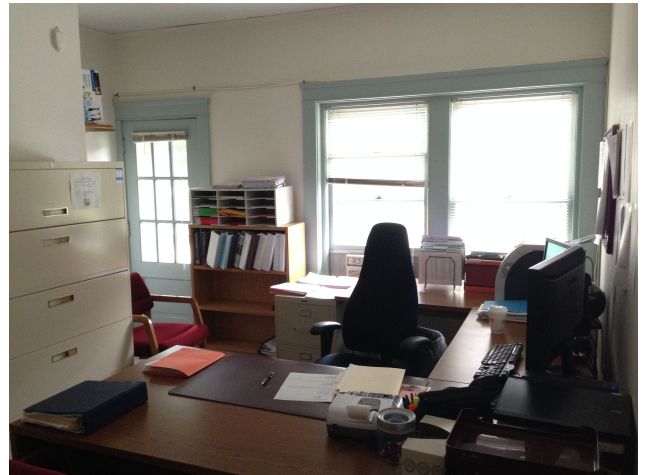
Interior – Second Floor egress balcony door

- Some doors and door openings are too narrow, are no longer Code-compliant and should be replaced.
- Egress path width and continuity. Egress path narrows towards egress door, the step risers and treads have differing height. Stair will need to be rebuilt to comply with Code.
- Overflowing storage and equipment present potential fire and tripping hazard. Excess materials and equipment should be removed and/or proper storage should be provided.

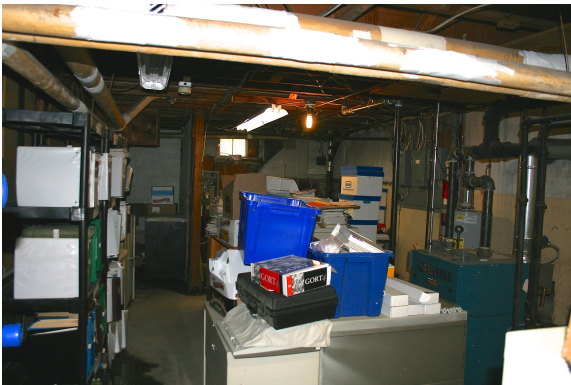
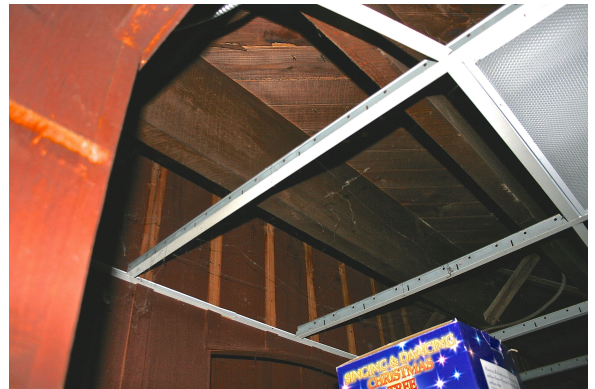
Interior - Basement

The Basement Mechanical/Storage Room does not have a floor drain. Rain or ground water appears to be leaking through the rear exterior wall by the boiler flue penetration. Water is collecting on the floor and may damage nearby stored paper items.

- Install a master mixing valve on the domestic hot water heater. Store hot water at 140 degrees to avoid Legionnaires' Disease.
- Repair leak in basement wall to protect stored items.
- Replace the water closet seats with open seats less the cover to comply with code.

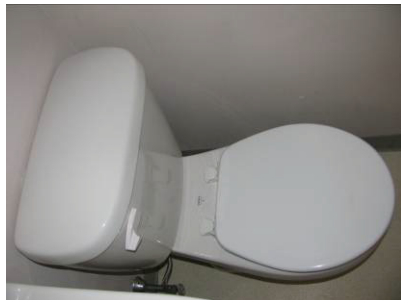
Typical Water Closet

The water closets are floor mounted, 1.6 gallons per flush, round front, tank type, not elongated bowl, with closed front seat and cover. The water closet is not handicap accessible.

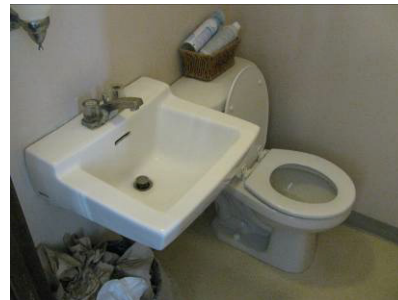
Typical Lavatory

The lavatories are compact, wall hung vitreous china. The faucets are center-set hot and cold water mixing type with knob handles. The lavatories are not handicap accessible or metering type.

- The 40 gallon gas water heater provides much more water than the two lavatories can use and appears to be greatly oversized. Provide a smaller electric water heater.
- Replace the existing plumbing fixtures with fixtures that meet the requirements of the plumbing code for water conservation and the MAAB for the requirements of accessibility.

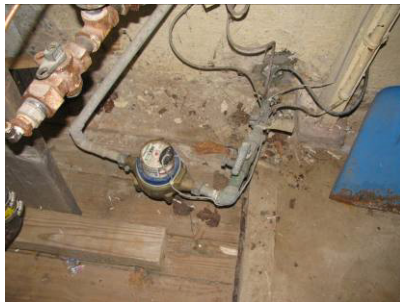
Water Meter

The domestic water service enters the basement of the building. The 3/4" domestic water service is located in the front Storage Room. There is a 3/4" water meter located on the service; however, there is no backflow preventer on the incoming service which is not required by code but will need to be verified if required by the water department. There is a Watts 9D backflow preventer on the boiler water make-up. The vent on the backflow device is piped to the floor and may discharge water onto nearby stored items.

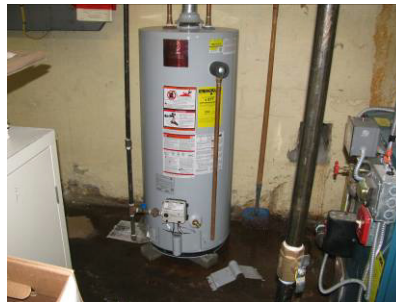
Water Heater

Domestic hot water is provided by a storage type gas heater with 40 gallon storage capacity and 40,000 BTUH input. There is no thermostatic mixing valve on the hot water system which protects the patrons from scalding.

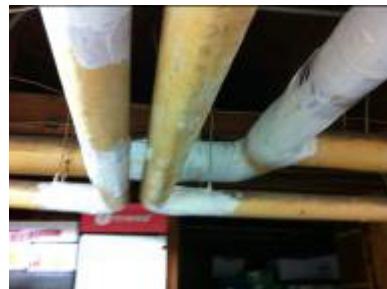
Piping Insulation

The boiler located in the basement level is a Burnham gas fired tube boiler which generates steam and supplies heat to the entire building through floor mounted cast iron radiators. The main heating boiler utilizes schedule 40 black steel piping for distribution. The piping system appears to be insulated with fiber glass insulation on the mains which is original to the building. The elbows however, appear to asbestos. Combustion gases generated from the boiler exhaust to an existing masonry chimney through a galvanized steel uninsulated breeching system. Combustion air for both boilers is provided through natural building infiltration which is not code compliant and requires an upgrade. The boiler is provided with all operating and safety controls including high and low limit. At this time the boiler, associated controls and piping system appear to be operating satisfactorily however, piping insulation is in need of being replaced.

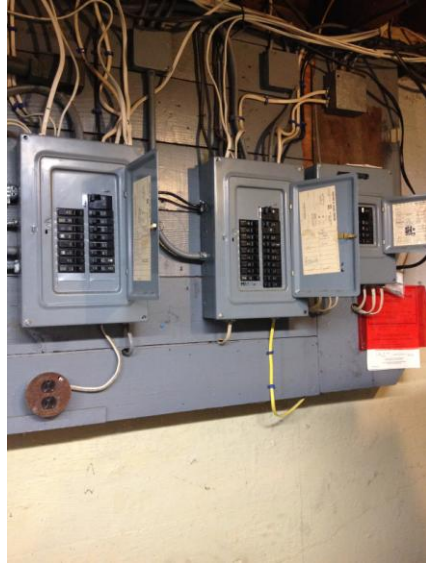
Load Center

Two (2) 100 ampere main breaker load centers, 120/240 volt, 1 phase, 3 wire are located in the basement. Panels are full and in fair condition. Both panels have been combined into one common service. The meter number is 75757862.

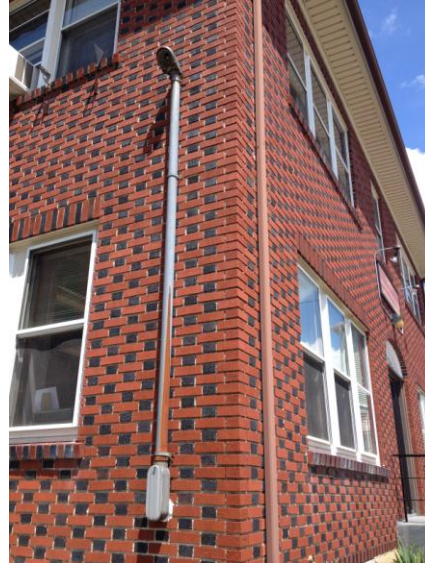
Abandoned Second Service Weatherhead

Secondary service runs overhead across Main Street to utility pole # 120-1 at the rear of the parking lot. Two meter sockets, one inactive, are located on exterior of the building. A second service drop weatherhead has been abandoned in place, conductors have been removed.

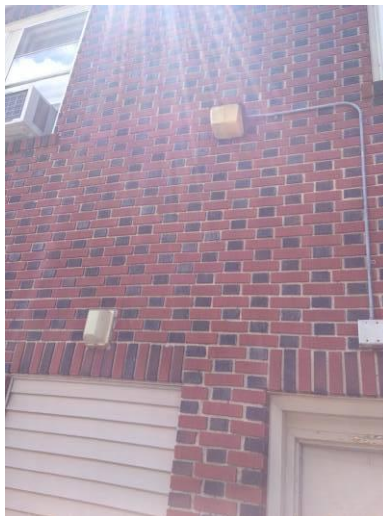
Exterior Lights

Exterior lights consist of HID wall packs and mini sconces over doors.

- Replace exterior lights with LED cut-off fixtures.
- Properly support Romex wiring in Basement.

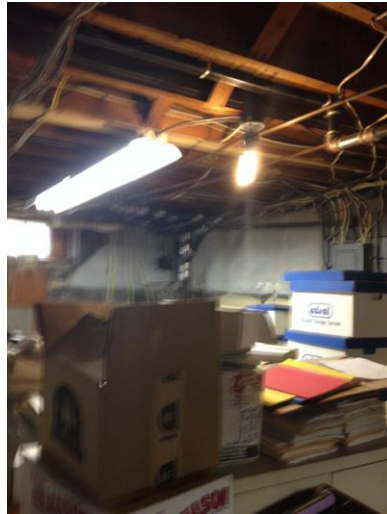
Basement Lights

Interior lighting consists of industrial strips and open grid 2x4 troffers in basement. First floor offices have recessed 2x4 troffers with T8 lamps. Second floor has open channel strips with T8 lamps. Second floor corridor has a porcelain socket with a pull chain. An open fluorescent circline fixture without lens is located in stairwell. Offices have wall mounted occupancy sensors.
