Leicester Public Schools – FACILITIES MASTER PLAN 6.0 Existing Conditions Analysis / Documentation **Primary School**

Leicester Public Schools – FACILITIES MASTER PLAN 6.0 Existing Photos – PRIMARY SCHOOL

Leicester Public School District Facilities Study Primary School Leicester, MA Plumbing/Fire Protection Existing Conditions Systems Report J#330 038 00.00 L#45295/Page 1/August 22, 2014

Leicester Public School District Facilities Study Primary School HVAC Existing Conditions Systems Report J#385 001 00.00 L#45307/Page 1/August 22, 2014

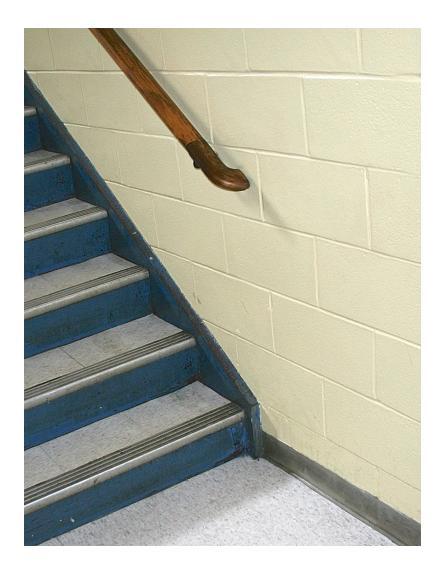
• Egress path width and continuity needs to be maintained, some barriers need to be removed. Stairs are not compliant with current Codes.

Existing Stair, typical

8	GUARDRAILS, HANDRAILS, TREADS AND RISERS DO NOT COMPLY WITH ACCESS AND CURRENT BUILDING CODE REQUIREMENTS. TYP.	REPLACE GUARDRAILS AND HANDRAILS	3
9	CIRCULATION DESK DOES NOT COMPLY WITH ACCESS REQUIREMENTS.	PROVIDE ADA-COMPLIANT ADDITION TO DESK	1
10	GUARDRAILS DO NOT COMPLY WITH ACCESS AND CURRENT BUILDING CODE REQUIREMENTS. TYP.	REPLACE GUARDRAILS	1
11	DRINKING FOUNTAIN DOES NOT COMPLY WITH ACCESS AND CURRENT BUILDING CODE REQUIREMENTS. TYP.	INSTALL CODE-COMPLIANT HI-LO DRINKING FOUNTAIN, BUILD WING WALLS	1
12	SINK AND CASEWORK DO NOT COMPLY WITH ACCESS REQUIREMENTS.	PROVIDE ACCESSIBLE SINK AND CASEWORK	1
13	CEILINGS IN POOR CONDITION AND HAVE EXCEEDED EXPECTED LIFE	INSTALL NEW CEILINGS THROUGHOUT	3
14	CASEWORK IN POOR CONDITION AND HAS EXCEEDED EXPECTED LIFE	REPLACE CASEWORK THROUGHOUT	3
15	FLOORING IN POOR CONDITION AND HAVE EXCEEDED EXPECTED LIFE	INSTALL NEW FLOORING THROUGHOUT	3
16	ROOM SIGNAGE IS NONCOMPLIANT	INSTALL CODE-COMPLIANT ROOM SIGNAGE THROUGHOUT	1

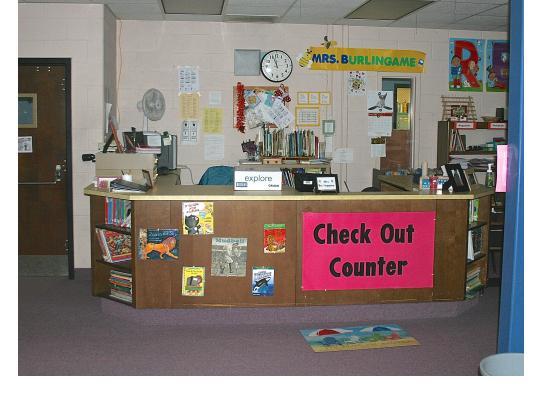
Library – Circulation Desk

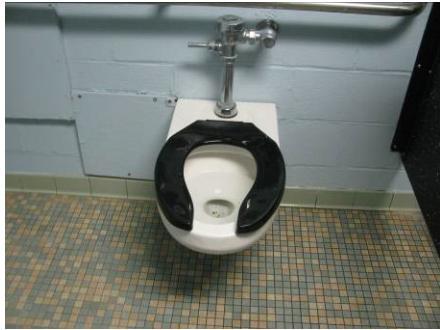
The fixtures are original or have been replaced as needed over the years. Many of the fixtures do not meet the requirements for handicap accessibility or the water conservation requirements of the Plumbing Code.

Typical Water Closet

• Replace the existing plumbing fixtures with fixtures that meet the requirements of the plumbing code for water conservation and the MAAB for the requirements of accessibility.

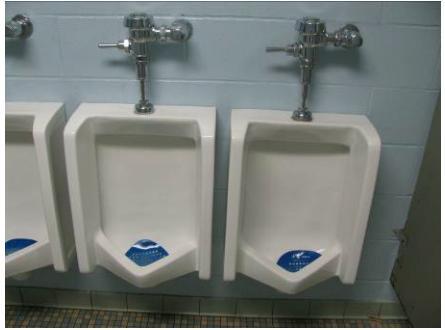
Typical Urinals

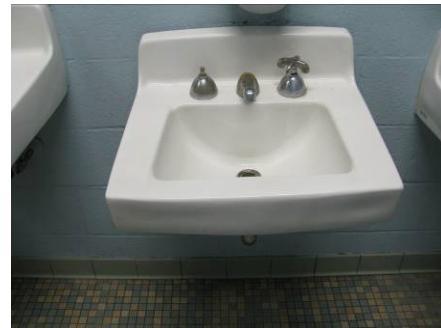
The classroom sinks are single bowl, self-rimming stainless steel sink. The faucet is a hot and cold water mixing faucet with a swivel spout and lever handles. Some hot water handles have been removed.

Typical Lavatory Missing HW Handle

- Install a master mixing valve on the domestic hot water heater. Store hot water at 140 degrees to avoid Legionnaires' Disease.
- Install hot water handles on all lavatories and sinks. Provide lavatories and sinks with individual mixing valves if there is a concern with students coming in contact with 120 degree water.
- Confirm the domestic hot water recirculation system is working and fix any deficiencies.
- Rod, clean out and camera the Boiler Room floor drain to clear any blockages.

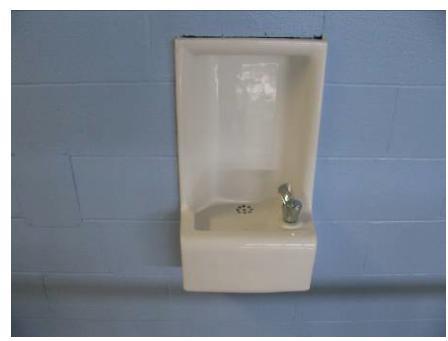
The drinking fountains are wall hung, semi-recessed vitreous china fixtures with push button operator. Fixtures are generally not handicapped accessible.

Typical Drinking Fountain

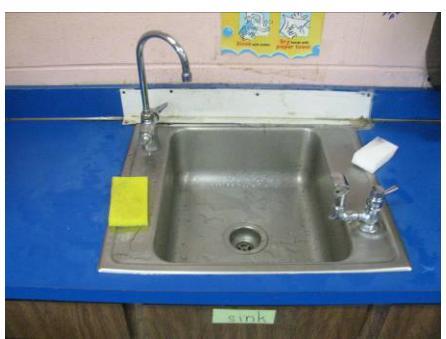
Typical CR Sink Missing HW Handle

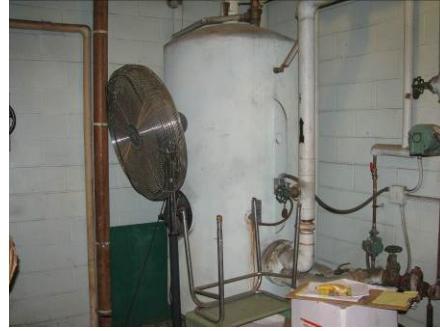
Water Heater

• Replace the existing water heater with a new high efficiency oil or gas fired water heater so the boiler can be shut down in non-heating months. Natural gas is preferred if available, in which case a high efficiency condensing water heater may be used.

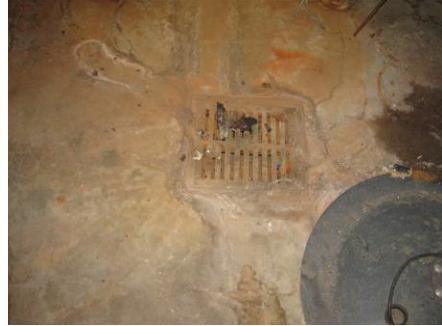
Boiler Room Floor Drain

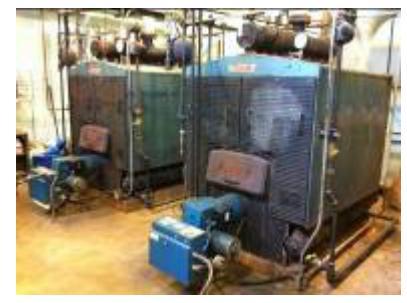
The Primary School has received poor maintenance on the heating system and equipment over the past years. The boiler system presently installed is original to the building and is currently in poor operating condition. Controllability of the present system utilizes pneumatic controls which should be upgraded to achieve better efficiencies and to reduce energy consumption.

The existing oil fired cast iron boilers are manufactured by HB Smith, each have a capacity of 2045 MBH and are equipped with Power Flame oil fired burners. Each burner has a firing rate of 21.1 GPH. No.2 fuel oil is stored in an outdoor above ground storage tank which has a capacity of 10,000 gallons. There is a monitoring system installed which is manufactured by Omntec, this system monitors the volume of oil within the tank. Fuel oil travels within schedule 40 black steel pipes between the outdoor tank and the indoor day tank through the use of the fuel oil pumps. The fuel oil pumps maintain pressure and oil within the day tank and the burners feed from the day tank which appears to be relatively new and operating satisfactorily. The day tank is provided with a rupture tank in the event there is a failure in the tank itself. The boilers generate hot water and supply heat to the entire building through the use of wall mounted unit ventilators for all classrooms and indoor air handling units for the large group spaces such as the Gym and library. Hot water is distributed throughout the building through the use of two inline pumps manufactured by Chicago Pump Company. The pumps each have a 3HP motor with typical starters. The heating hot water piping distribution is schedule 40 black steel piping insulated with fiber glass insulation. Majority of the insulation appears original and in some locations the insulation is soiled and damaged. Majority of the elbows appear to be asbestos. Expansion for the heating hot water system utilizes a non-insulated vertical expansion tank. The system does not appear to be equipped with an air separator. For minimal energy saving the system is equipped with a compensated water valve and associated piping. Combustion gases generated from the boiler exhaust to an existing masonry chimney through a galvanized steel breeching system which is insulated with what appears to be calcium silicate. Combustion air for both boilers is provided through a mechanical fan assisted system. There are two combustion air fans which do appear to work however, they are original to the building and some components do appear to be broken. The boiler is provided with all operating and safety controls including high and low limit. At this time the boiler, associated controls and piping system appear to be operating however, due to the antiquated nature of the system replacement parts are becoming scarce. The boilers themselves are showing signs of future failures, there is currently wear and tear, corrosion and signs of leakage on the main barrels connecting to the cast iron sections. Their current condition is poor as well as the inline pumps which are also showing signs of failure and leakage.

HW Boiler Plant

- Provide new high efficiency condensing boilers.
- Provide new inline system pumps with premium efficiency motors and variable frequency drives.
- Provide new indoor air handling units with premium efficiency motors and variable frequency drives.
- Provide a new direct digital control system including control valves, digital thermostats with feedback, damper actuators with feedback, freezestat alarms, unit controllers, graphic software with trending and web access and integrate it into a town wide control system network.
- Provide packaged rooftop units for air conditioned spaces with digital scroll compressors and ECM condenser fan motors.

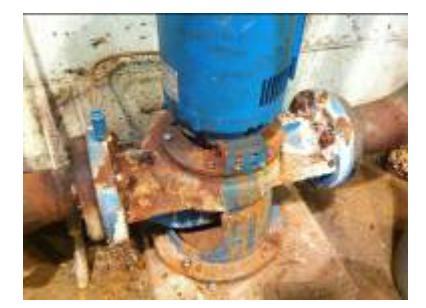
Typical Inline Pump

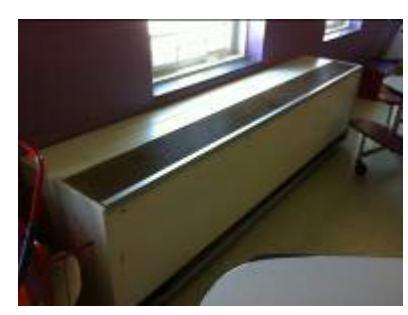
similar to that of the outside air damper. The unit ventilators themselves appear to be in fair to poor condition. They currently are operational and functioning as required however; several issues arise often throughout the school year mainly due to the control system and non-maintained components such as fan lubrication, filter changes and debris within the hot water piping system. Yearly maintenance should be performed on each unit consisting of filter change, fan motor lubrication, hot water piping treatment/cleaning and control valve exercising. Leakage within the pneumatic tubing throughout the building leads to issues with control valves and outside air damper not functioning. This in turn can relate to coil freeze ups and uncomfortable temperature swings.

Typical Unit Ventilator

- Insulate the hot water expansion tank.
- Repair/replace hot water piping insulation.
- Confirm and verify/replace combustion air fans for boilers.
- Provide complete service and maintenance of existing unit ventilators.
- Provide complete service and maintenance of existing exhaust fans.
- Provide complete filter changes quarterly per year.
- Provide complete service and maintenance of existing boilers.
