Evaluations of Existing Conditions

SECTION
3.1.4

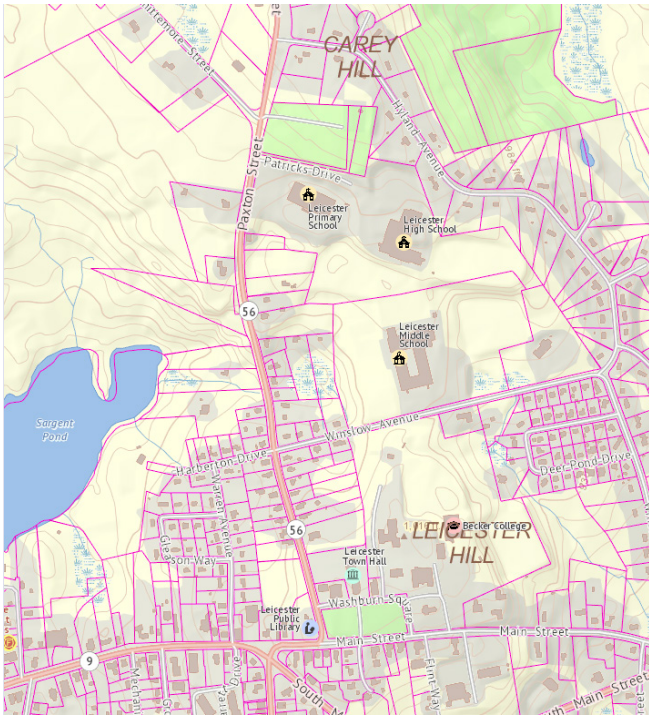
The existing Leicester Middle School was built to serve as the Town's High School in 1961 and was converted to use as a Middle School in 1994. The middle school site is bounded by the Leicester High School and Leicester Elementary School to the north, residential properties to the east, a wooded area and residential properties to the west, and Winslow Avenue to the south. There is a one-way entrance to the site from Winslow Avenue and a one-way exit from the site to Winslow Avenue. There are

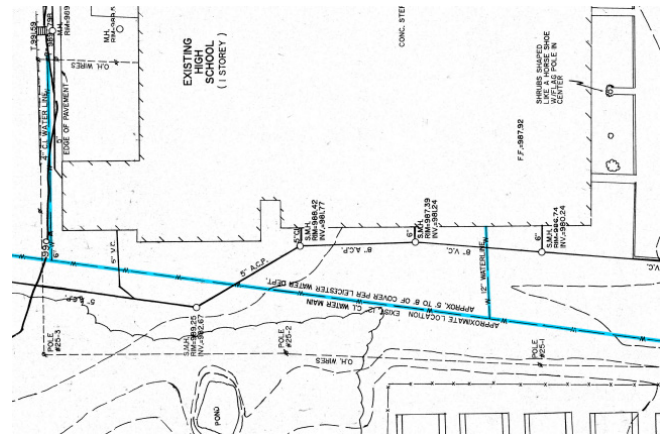
main and a 4-inch cast iron service from a fire hydrant near the utility area to the 12-inch main. There is a fire hydrant located along Winslow Avenue to the south of the building but the hydrant and connection from the hydrant are now shown on the record plans.

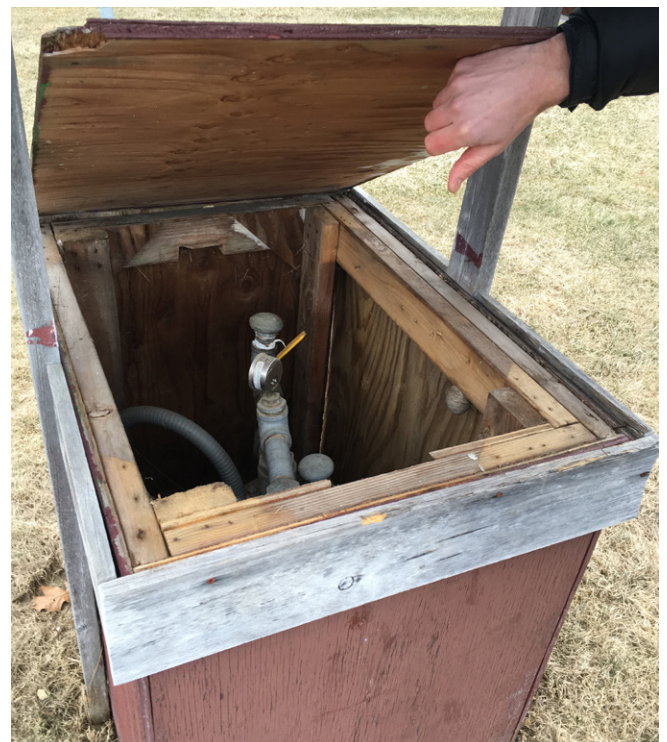
There appears to be a well located on the Middle School Site between the track and the athletic field to the east of the building. Neither the well nor piping from the well are shown on any record plans that Nitsch has reviewed.

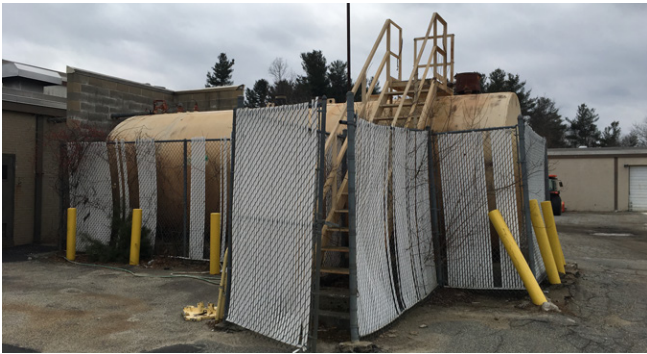
Nitsch Engineering observed what appeared to be blue dig safe markings along the wooded area to the west side of the building. The surface cover appeared to be recently disturbed. A neighbor to the high school indicated that a new water main had been installed through Patrick's Drive, a private road adjacent to the residential properties to the west of the school site. The neighbor believed work stopped at the middle school property, although the DIGSAFE markings and limit of disturbance appeared to be on the Middle School property. The School officials Nitsch Engineering spoke with had no knowledge of this work. It is unknown if this work connected to any main on the Leicester Middle School property.

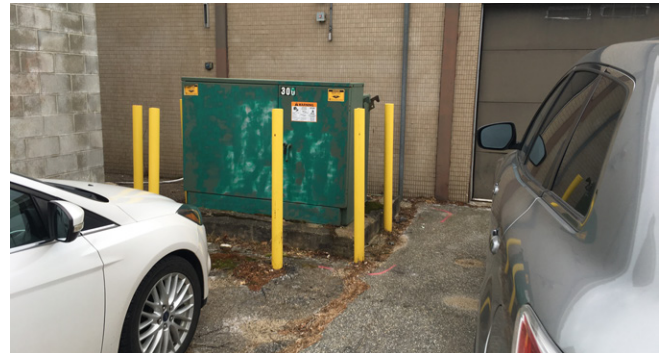
There is an oil tank located in the utility area to the north of the existing building. No information is available to Nitsch Engineering at this time regarding the size/condition of the tank. No underground fuel tanks were observed onsite and the record plans do not indicate any surface or buried tanks. See Mechanical, Electrical, Plumbing Engineer's narrative for additional information.

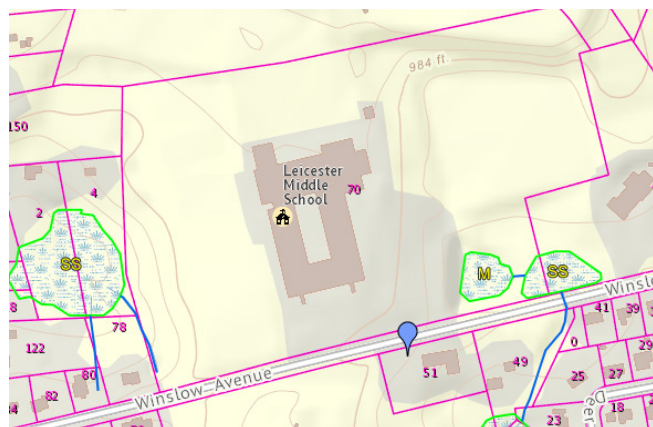
**PRELIMINARY PERMITTING CONSIDERATIONS
WETLANDS PROTECTION ACT (310 CMR 10.00)**

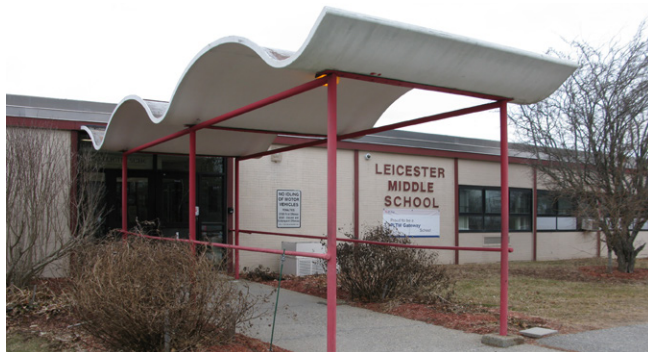
View at Main Entrance

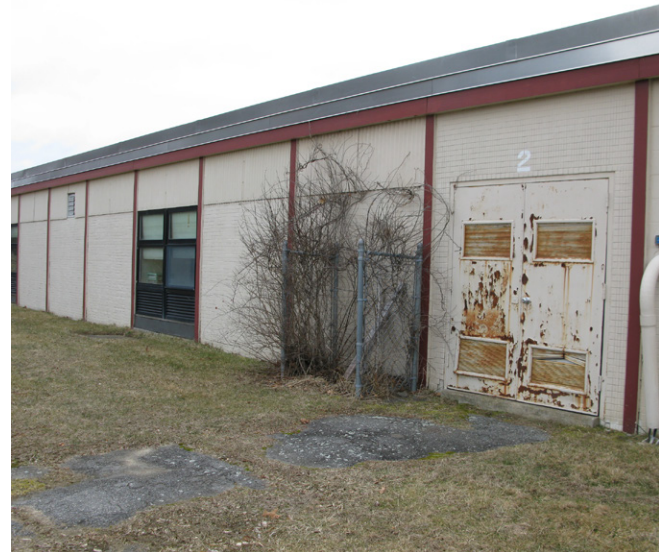
View at West Elevation

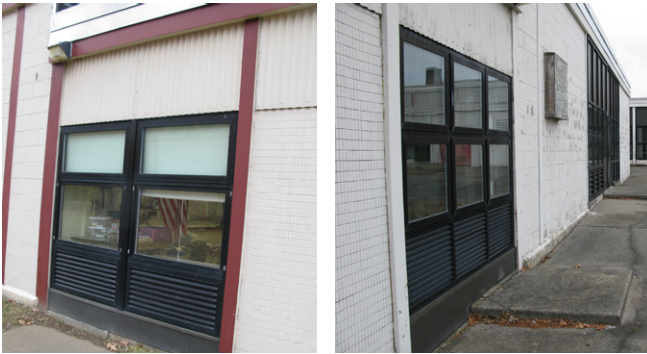
View of perimeter windows

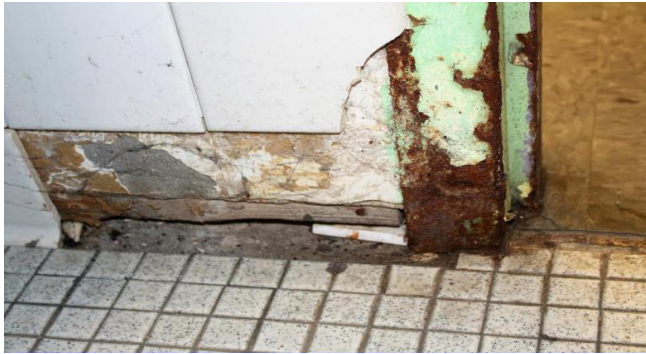
View of wall deterioration on Locker Rooms

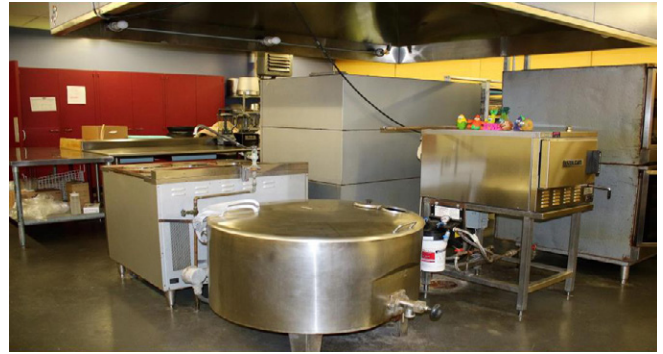
Numerous lockers are broken or missing doors.

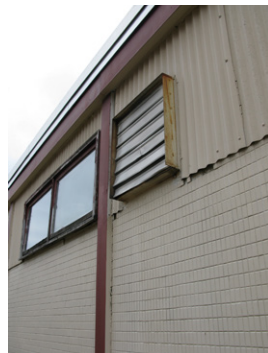
Poor condition of exterior wall assembly

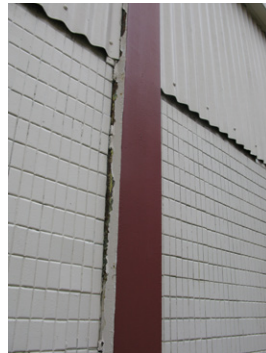
View of corrugated plastic, failing tile & rusted steel

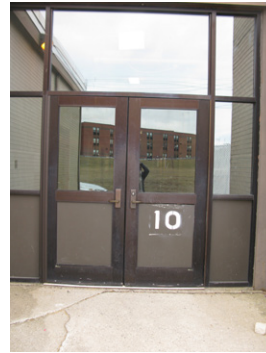
View at secondary entry

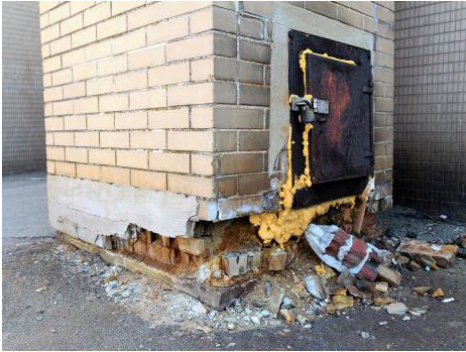
Masonry deterioration at chimney

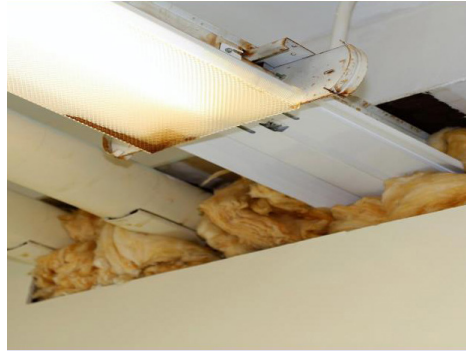
Light fixture penetrating stud wall

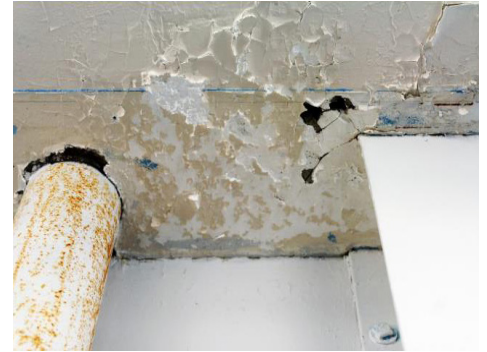
Water damaged plaster and paint

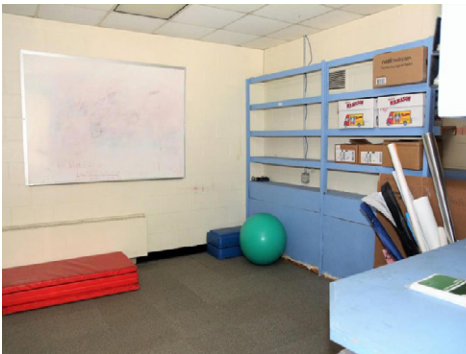
Poorly equipped OT/PT room

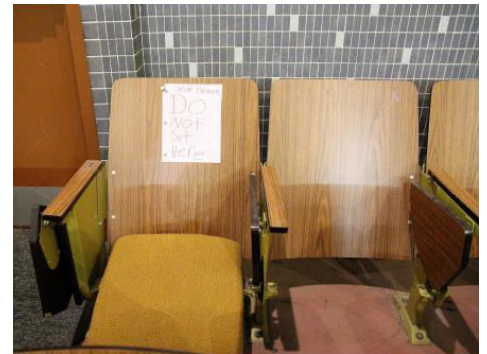
Damaged and inoperable seats in auditorium

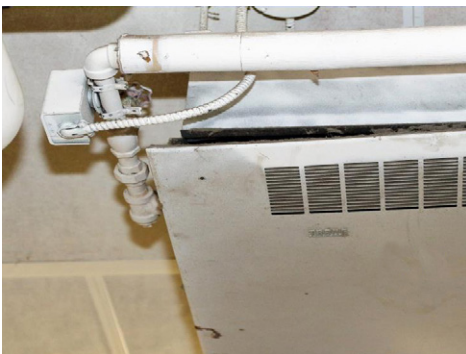
Retrofit mechanical equipment

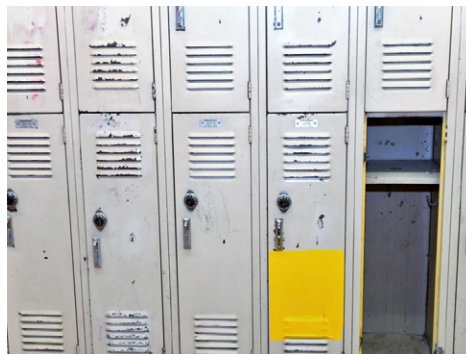
Damaged and inoperable lockers

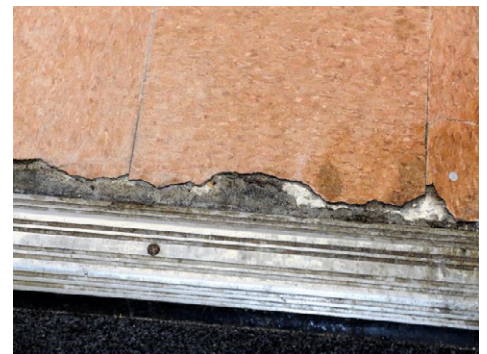
Damaged flooring at material transitions

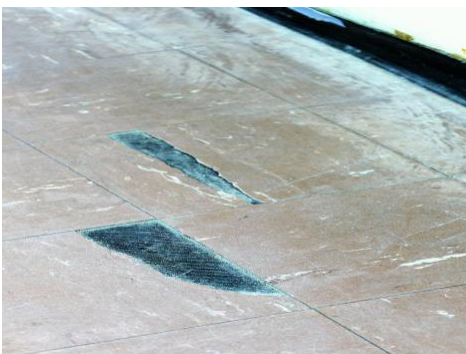
Damaged and worn flooring finishes

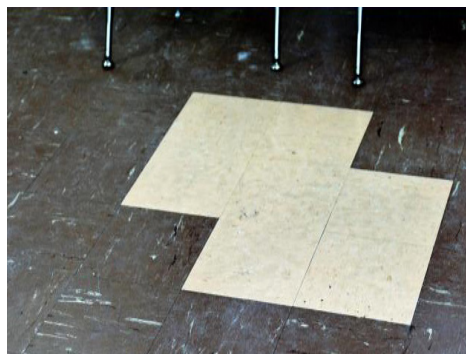
Poor patching of existing finishes

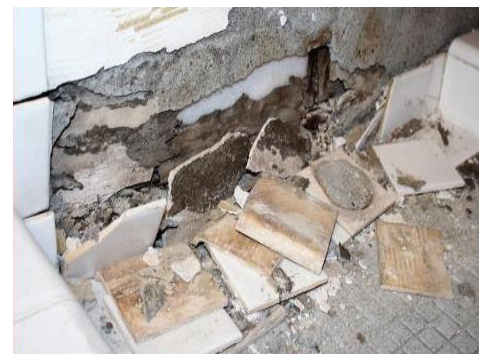
Damaged tile walls in Locker Rooms

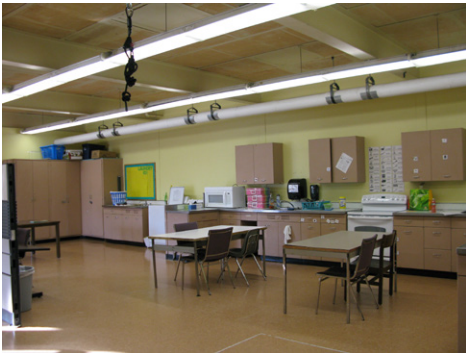
Non-compliant sinks, cabinets and clearances in Life Learning Classroom

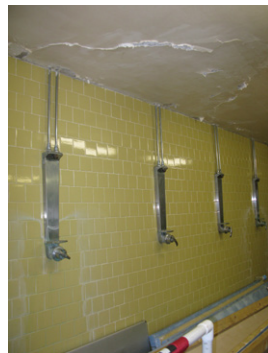
Non-compliant showers/water damaged ceiling

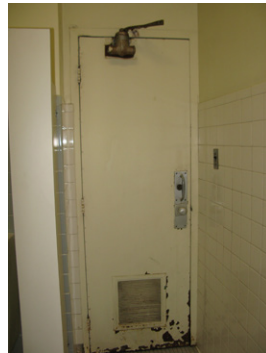
Non-compliant door clearances

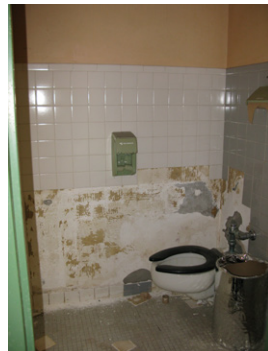
Deteriorated wall tile

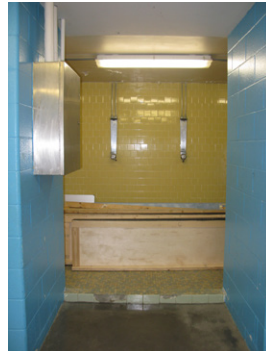
Non-compliant showers

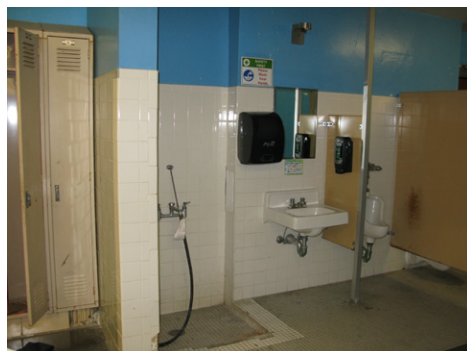
Non-compliant custodial sink. Damages wall/floor tile and plumbing fixtures

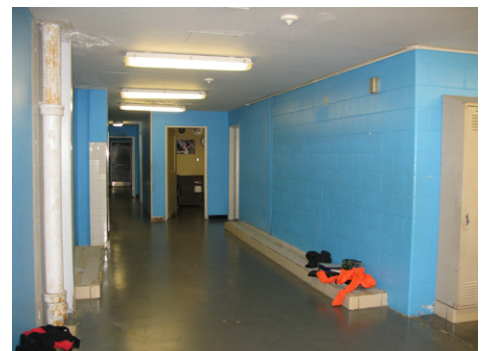
No lockers in Locker Rooms

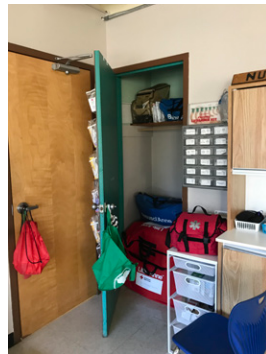
Inadequate storage in Nurse's Office

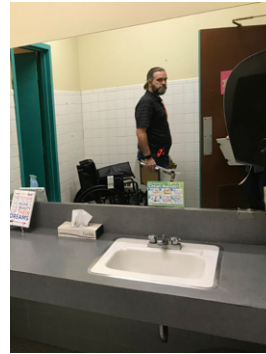
Non-compliant sink in Nurse's office bathrooms

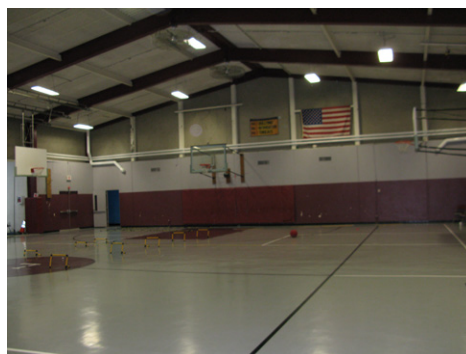
Undersized gymnasium with inadequate seating and spectator area

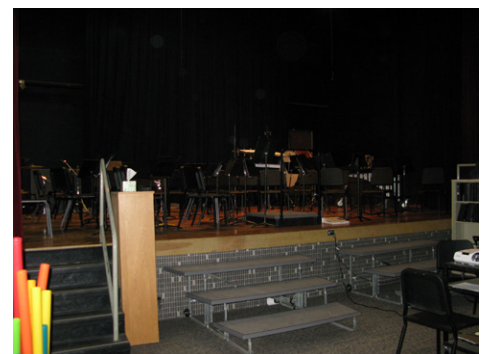
Non-compliant stage access

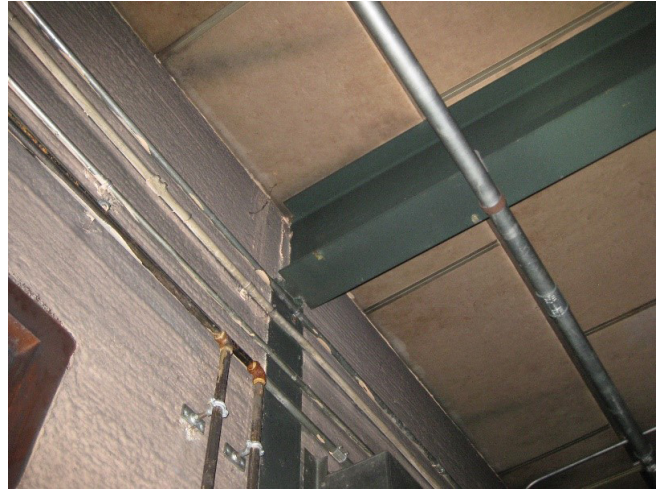
PHOTO 1: Interior beam framing into steel column. Concrete wall panel nested between column flanges.

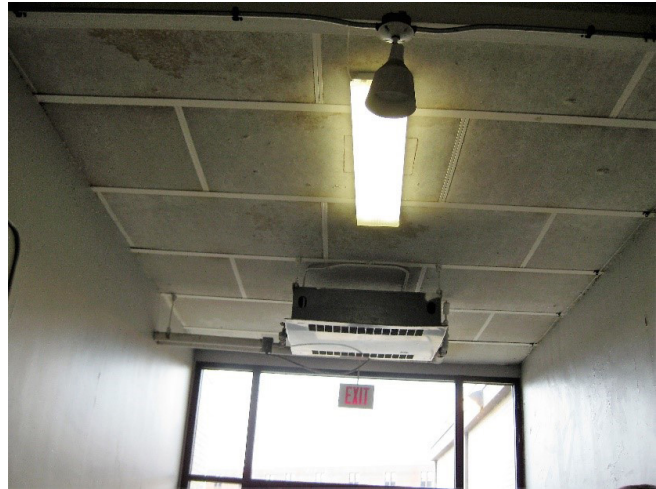
PHOTO 2: Minor water staining of gypsum roof panels

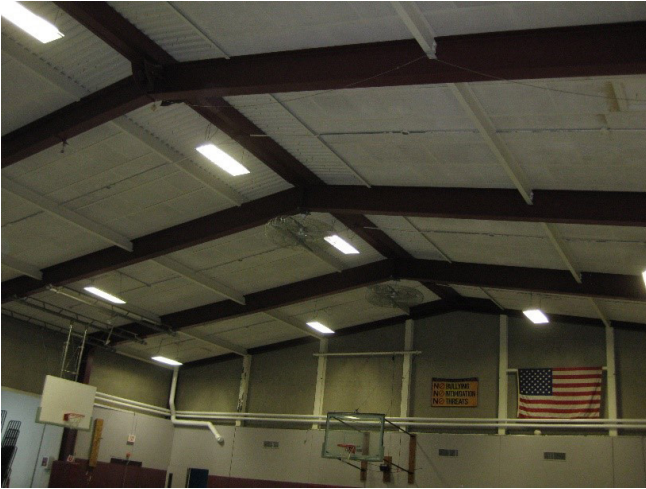
PHOTO 3: Steel roof bents in gymnasium

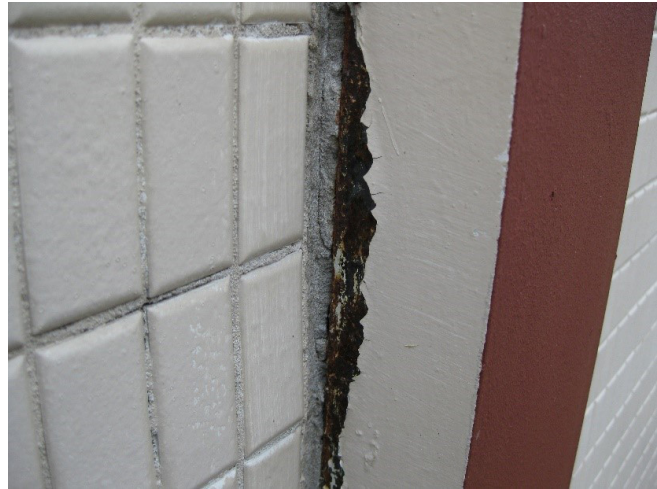
Photo 6: Close up of column showing slight rusting of steel

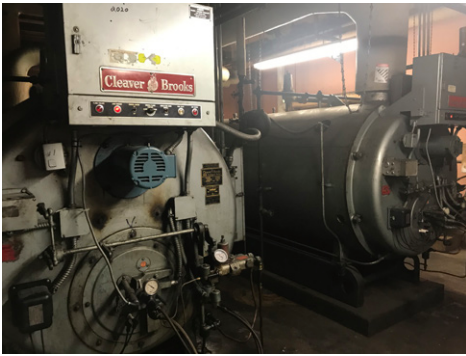
Existing Hot Water Boilers

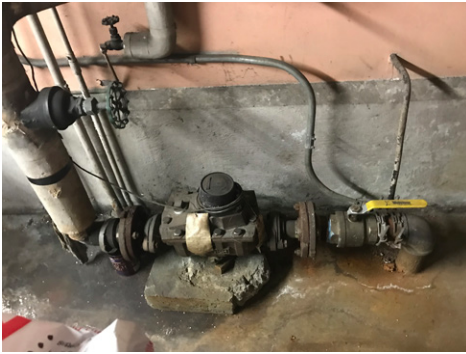
Domestic Water Service

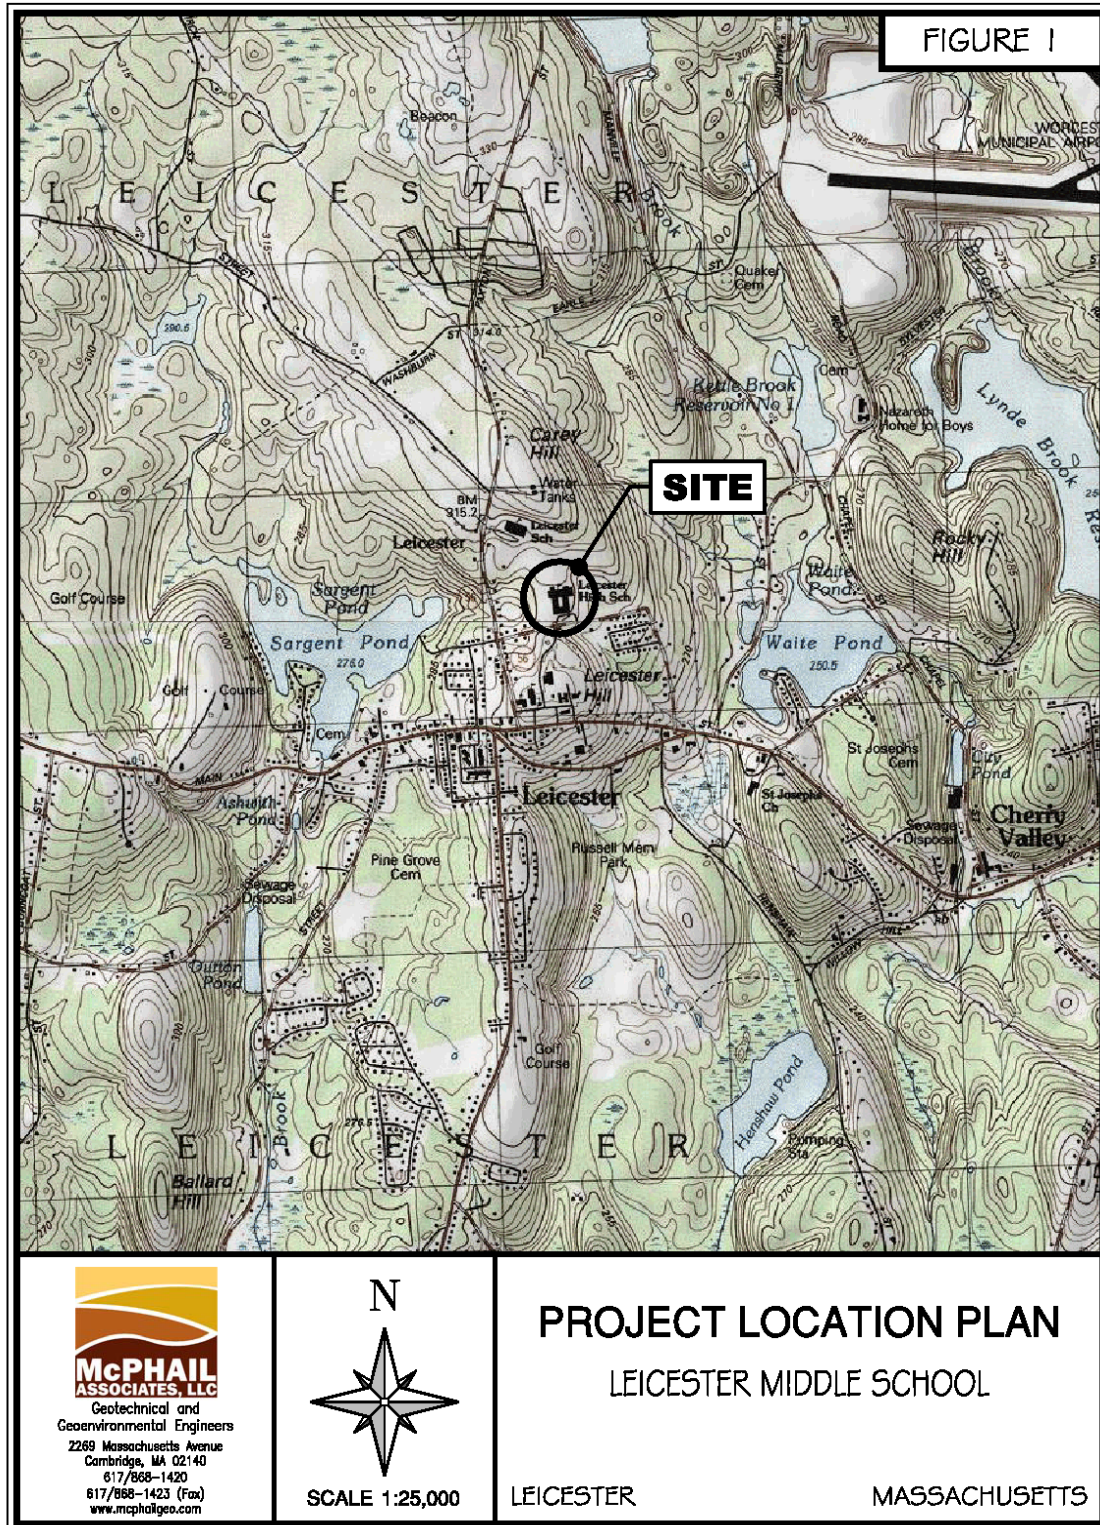
It is recommended that McPhail be retained to prepare a Final Foundation Engineering Report once the details of the proposed building project are finalized. The final report would provide final foundation recommendations based on the specific project design requirements. Additional subsurface explorations will be necessary to further delineate the subsurface conditions across the final building site.

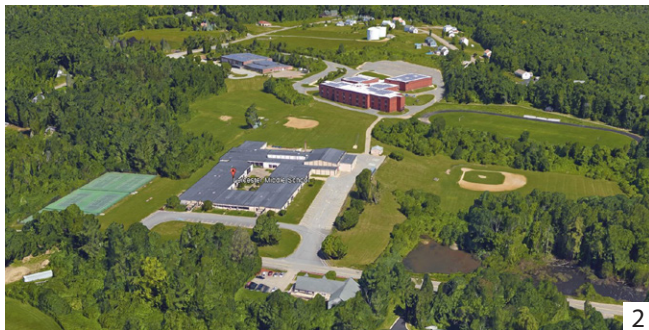
PHYSICAL CONDITIONS SUMMARY

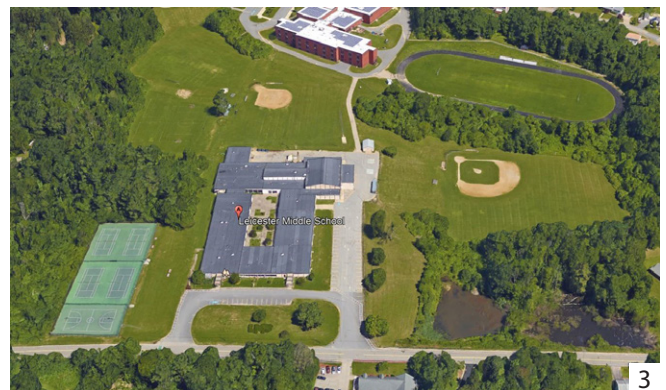
There is approximately 100-foot change in elevation from north to south across the site transitioning in terraces separated by steep slopes ranging from 20 to 30 feet

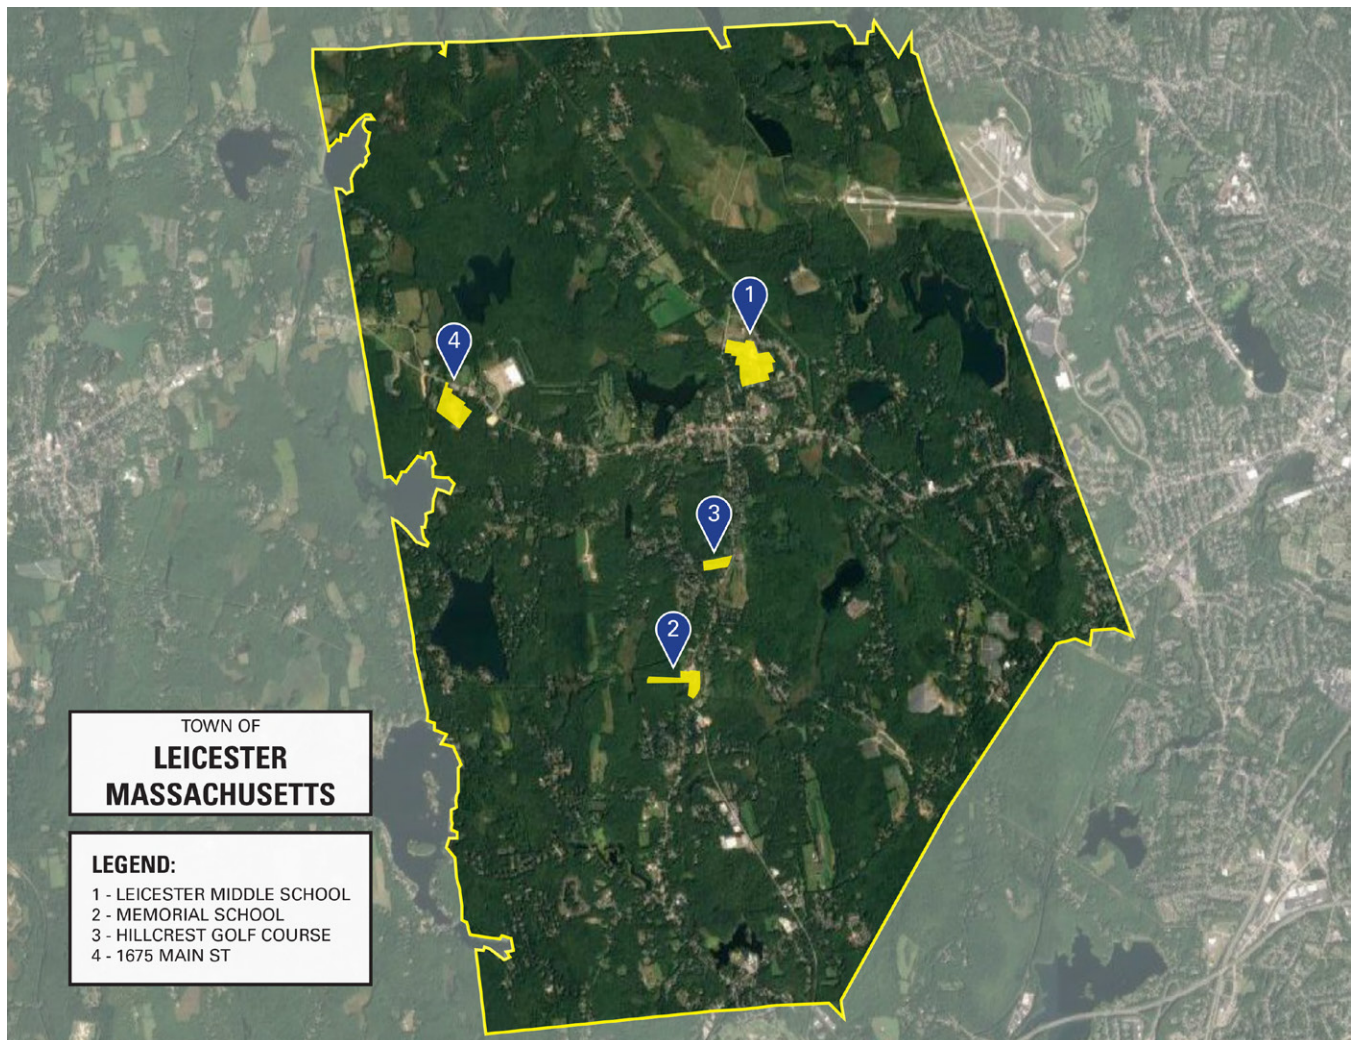
Leicester Middle School
43.7 Acres
Owner: Town of Leicester

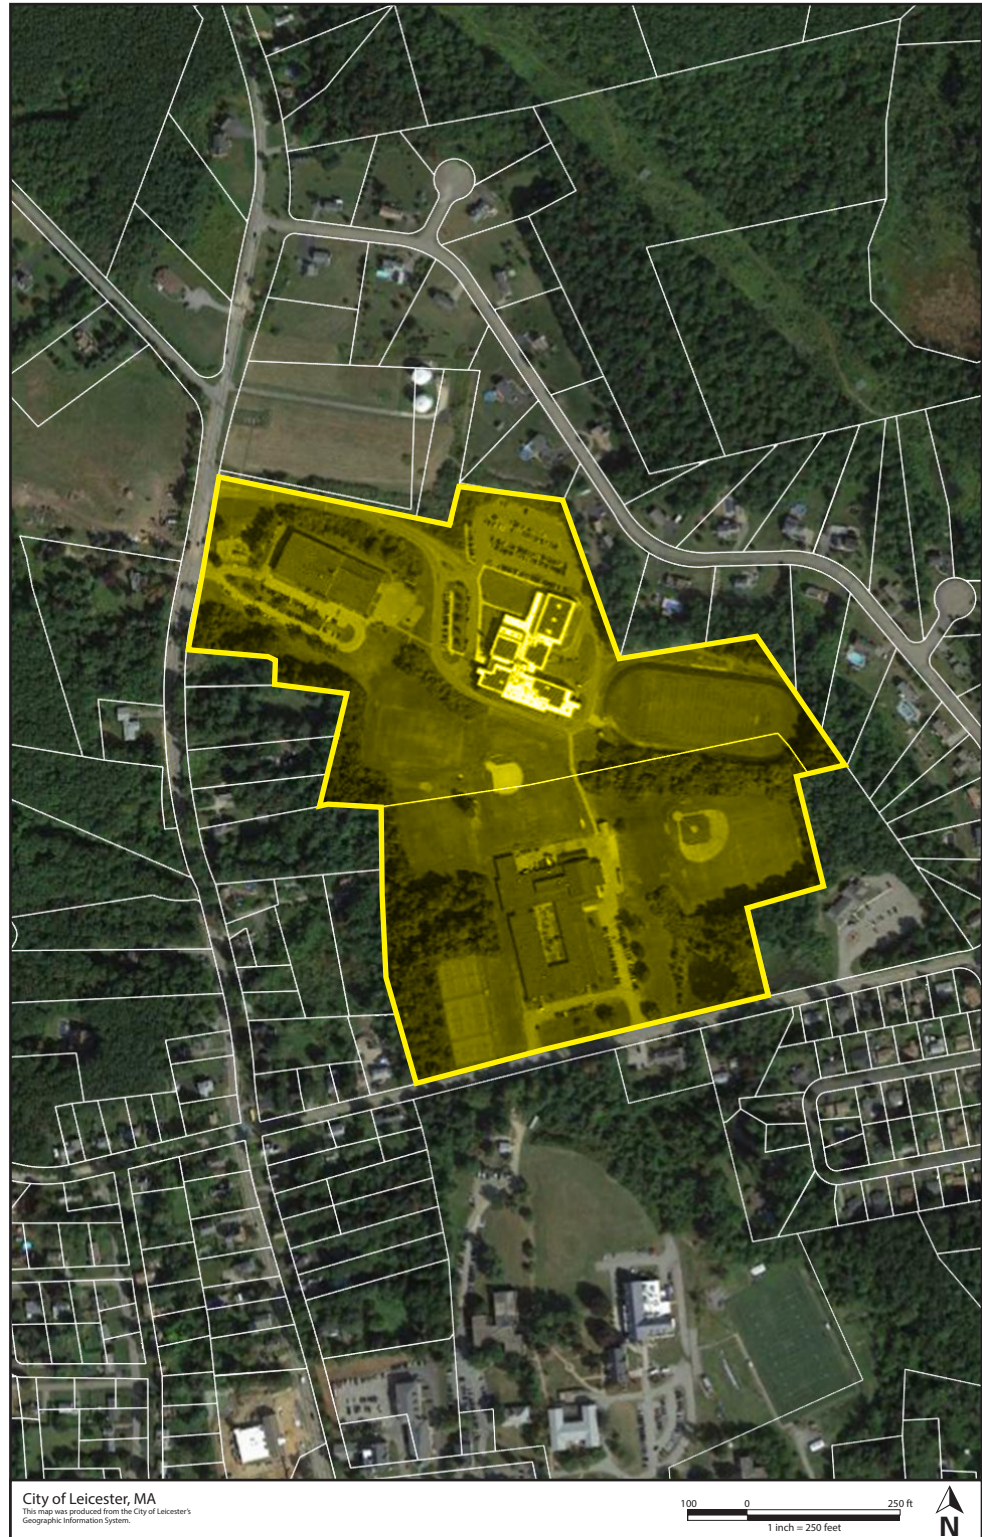
Memorial School
28.0 Acres
Owner: Town of Leicester

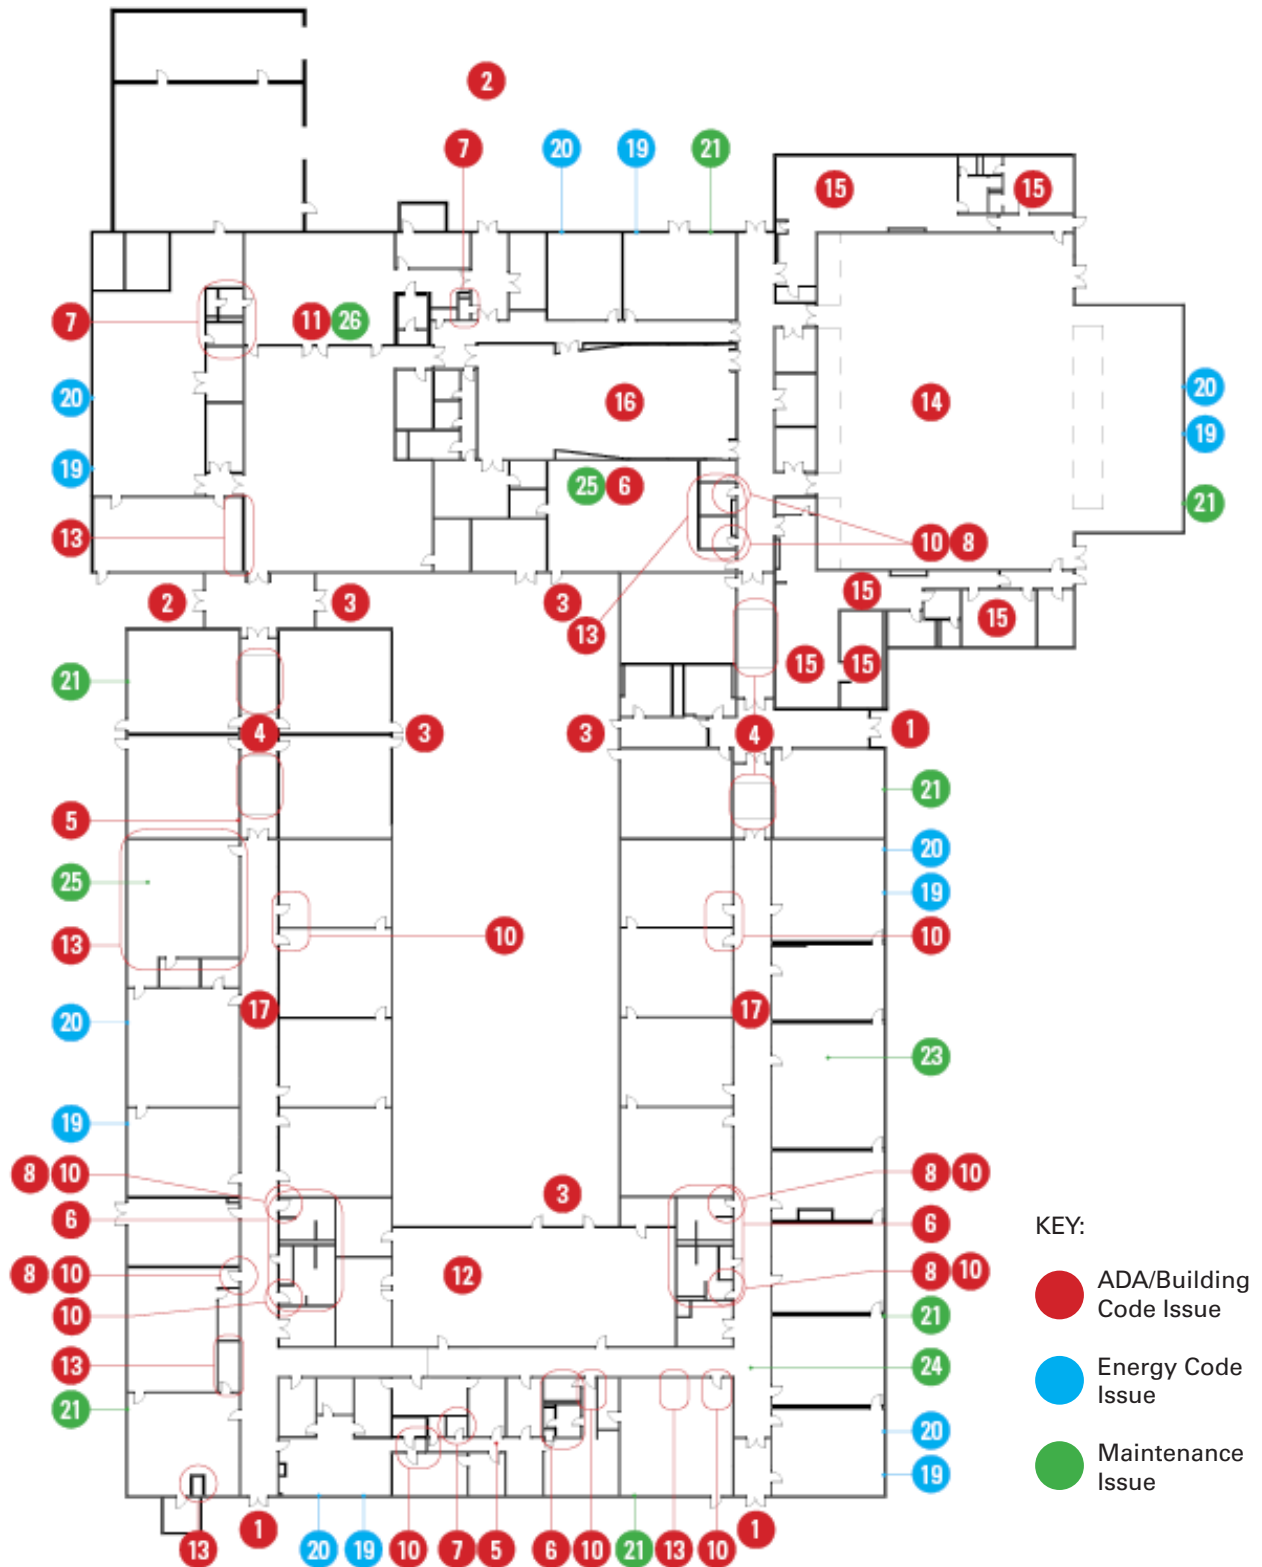
PROPOSED ALTERNATIVE: OPTION 1 - CODE UPGRADE OPTION (GRADES 6-8)

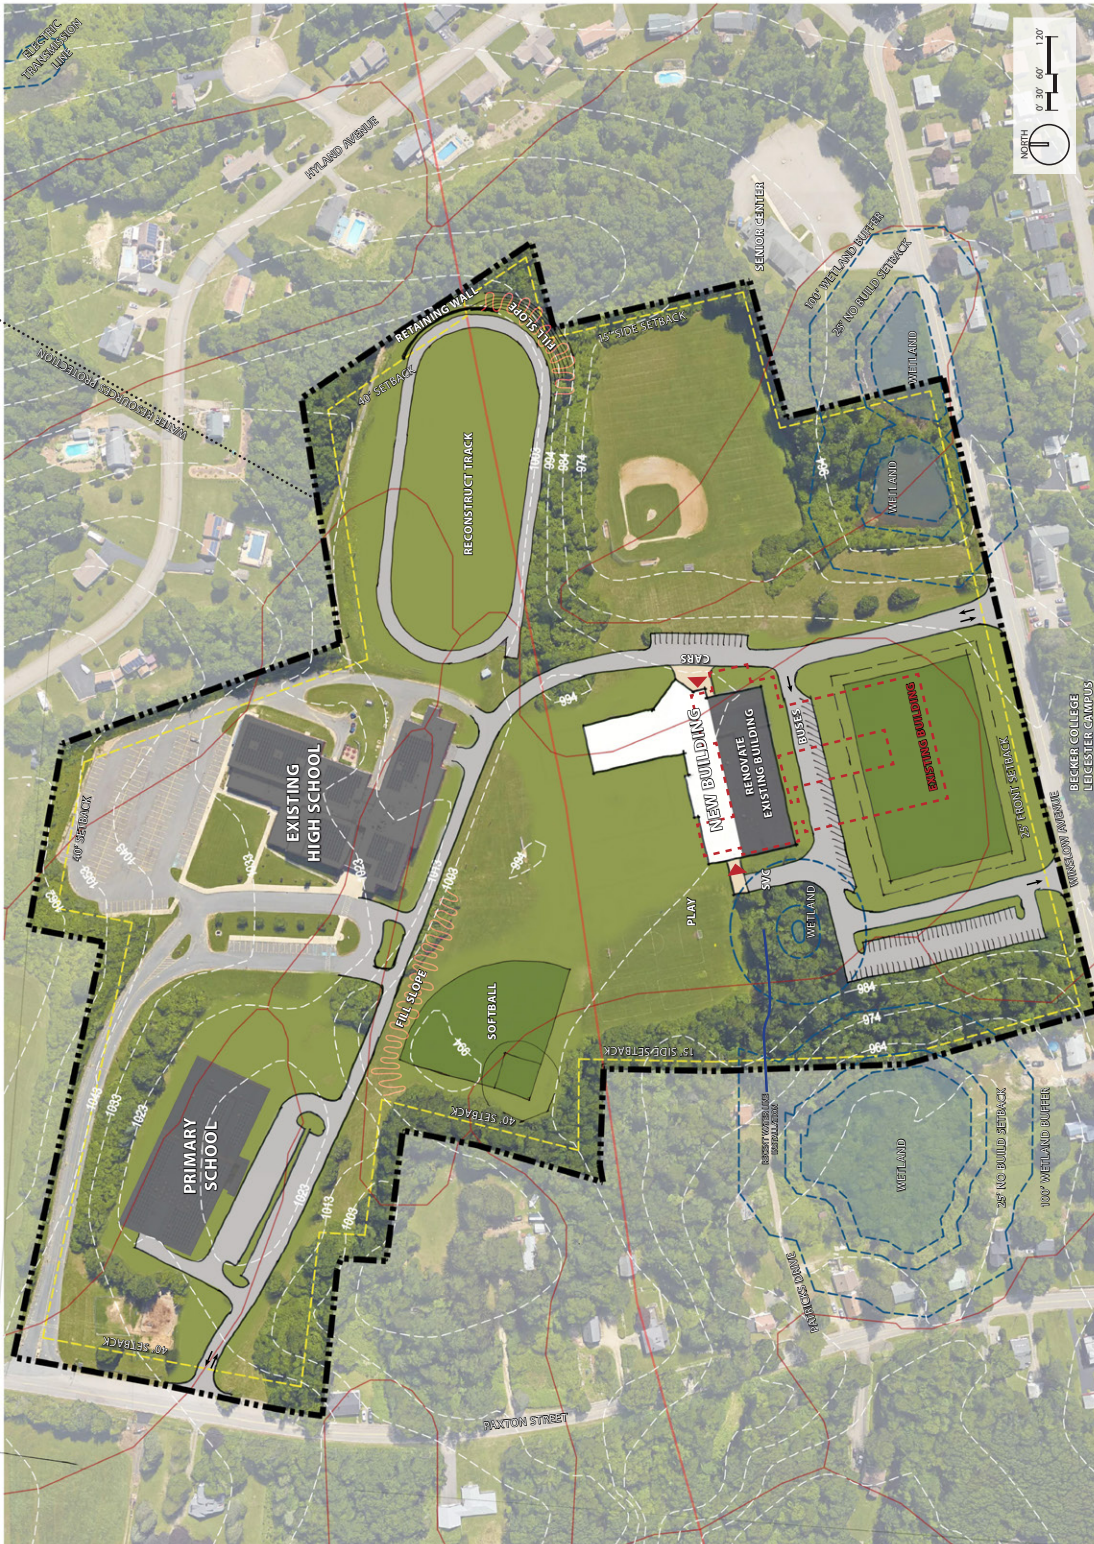
PROPOSED ALTERNATIVE: OPTION 2A – RENOVATION/NEW ADDITION (GRADES 6-8)
