# Phase I Environmental Site Assessment

Leicester Middle School  
70 Winslow Avenue  
Leicester, Massachusetts

March 2019

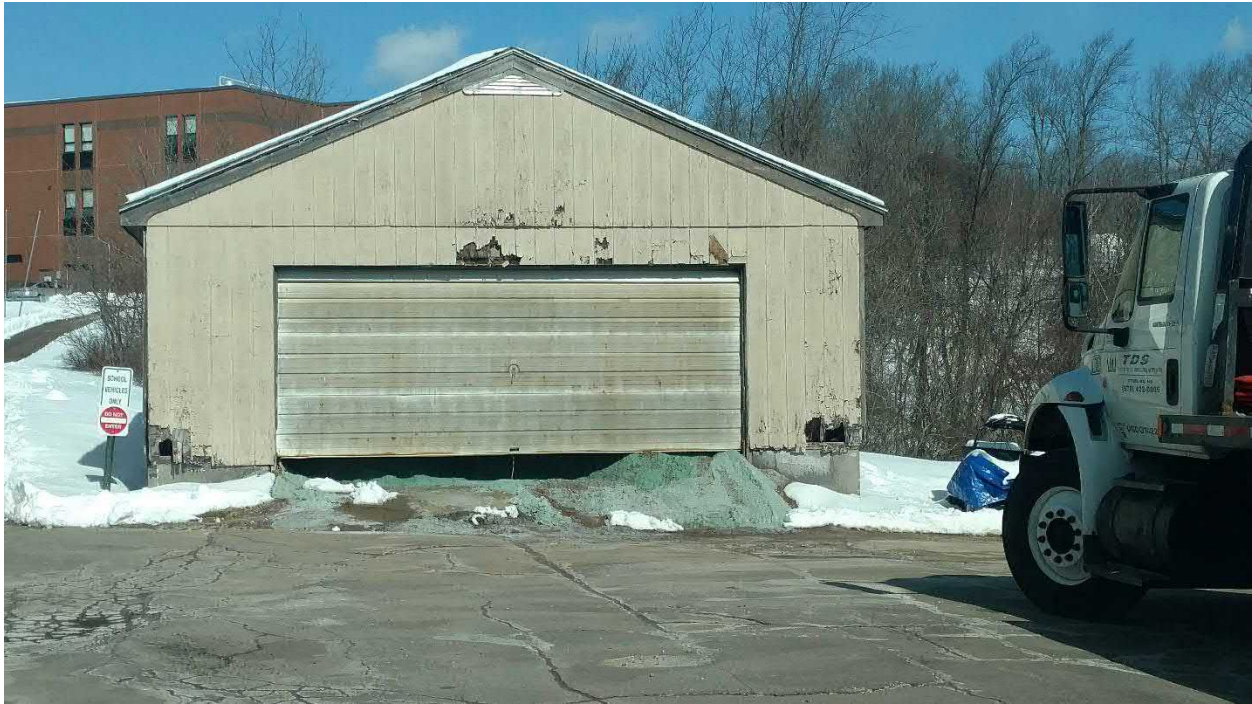
Garage in the northeastern corner of the Site that was storing salt.

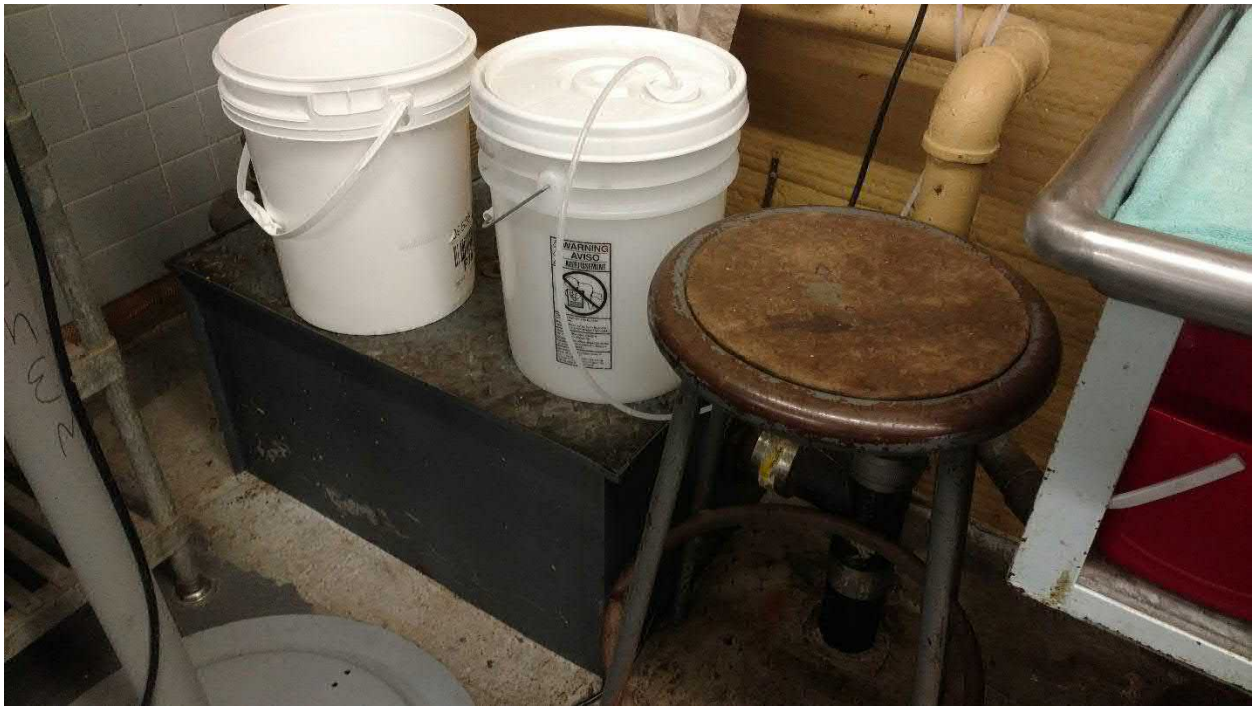
Cafeteria grease trap.

A grease trap is located in the kitchen. According to the cafeteria workers, the trap is cleaned approximately two times a year. A room off of the kitchen and cafeteria was used by the maintenance department as storage space for office supplies and cleaning products. The science teacher that manages laboratory chemicals stated that all flammable chemicals are stored in the maintenance department flammable cabinet. Chemicals that are stored in the laboratory classrooms are not flammable or hazardous. The maintenance department storage space abutted the maintenance garage, which stored grounds equipment such as tractors, lawn mowers, snow blowers, gasoline/oil, and athletic field paint. A floor drain was observed near the garage door, but the discharge location was not identified. Floor staining or evidence of discharge running to the floor drain was not observed.

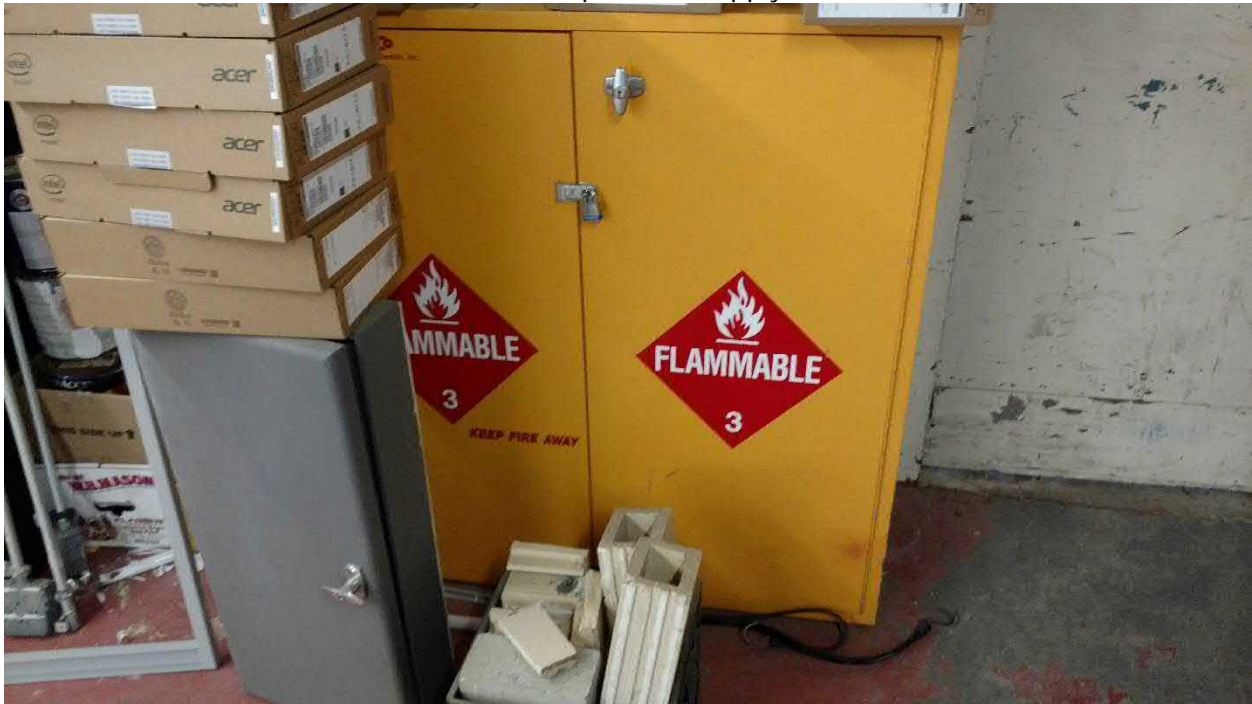
Flammables cabinet near the maintenance garage that stores science classroom chemicals.

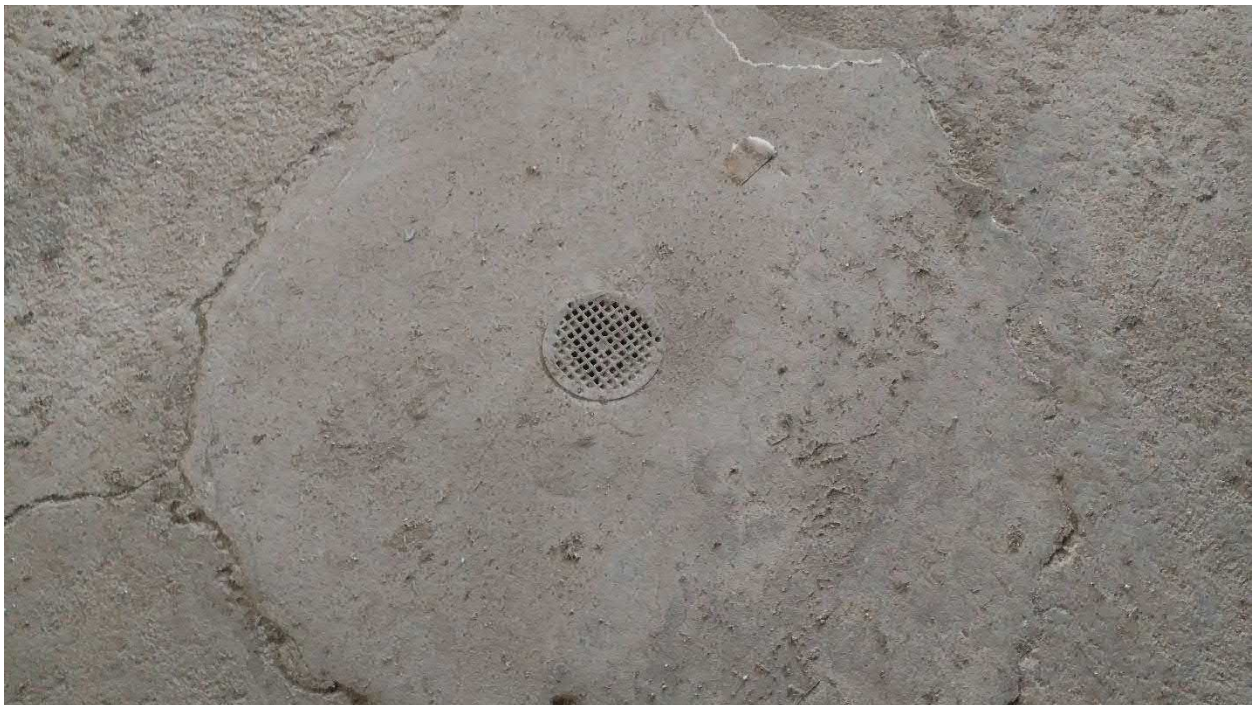
Maintenance garage floor drain.

Although not considered an REC, a floor drain was observed on the garage floor of the maintenance department. Lawn equipment and repair supplies (e.g. oil, petroleum, etc.) were stored in the garage. Staining on the garage floor or evidence of discharge flowing into the drain was not observed, eliminating a potential migration pathway. The discharge location of this floor drain should be located.

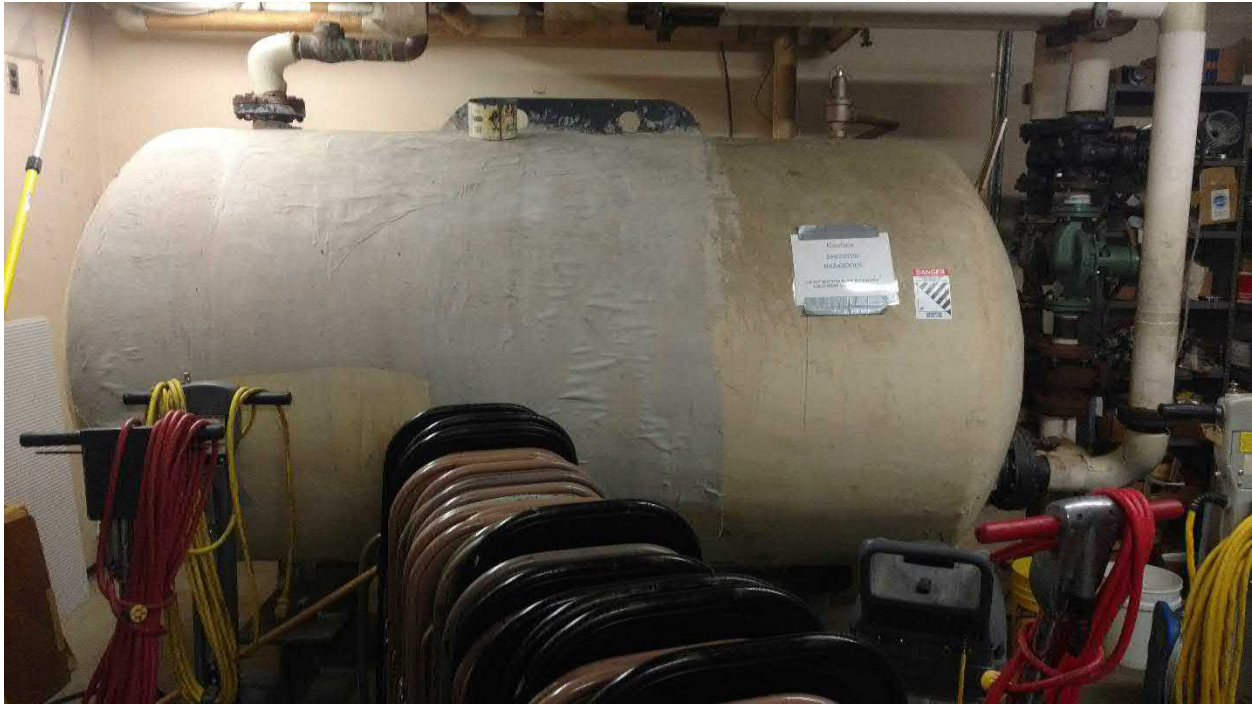
Boiler room.

The boiler system occupied two adjacent rooms, marked on a map of the school as the “custodial office” and “boiler room.” Two unwrapped furnace systems were located in the custodial office, and one wrapped furnace system was located in the boiler room. The wrapped furnace was marked with an asbestos warning sign. The remainder of the room was used as general storage for equipment repair materials, folding chairs, floor buffers, etc.

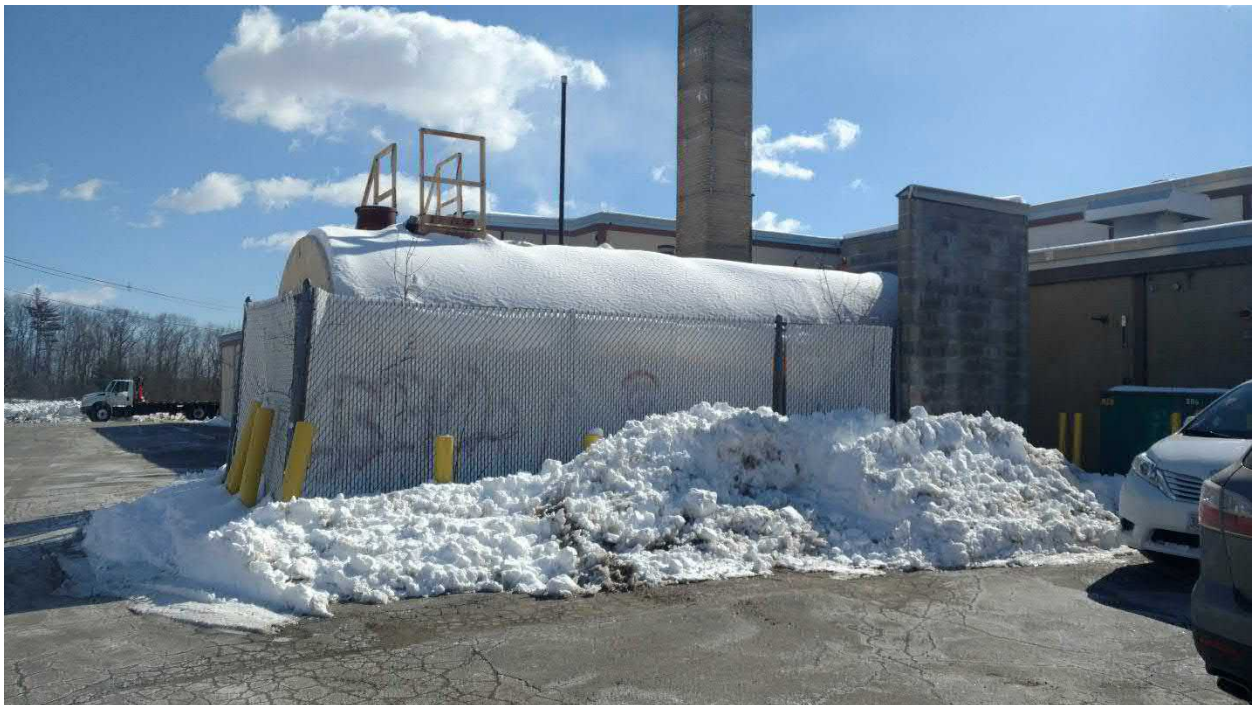
AST that fuels the boilers.

The 10,000-gallon AST was located along the northern exterior wall of the building, near the boiler rooms. The tank was located within a secondary containment system. Staining was not observed around the tank or within the containment system; however, observations were limited due to snow coverage.
